SEDIMENTATION STUDY OF THE MISSISSIPPI RIVER SANTE FE CHUTE, DOOLAN CHUTE HYDRAULIC MICRO MODEL INVESTIGATION

By Robert D. Davinroy David C. Gordon Robert D. Hetrick

U.S. Army Corps of Engineers
St. Louis District
Hydrologic and Hydraulics Branch
Applied River Engineering Center
Foot of Arsenal Street
St. Louis, MO 63118

September 1996

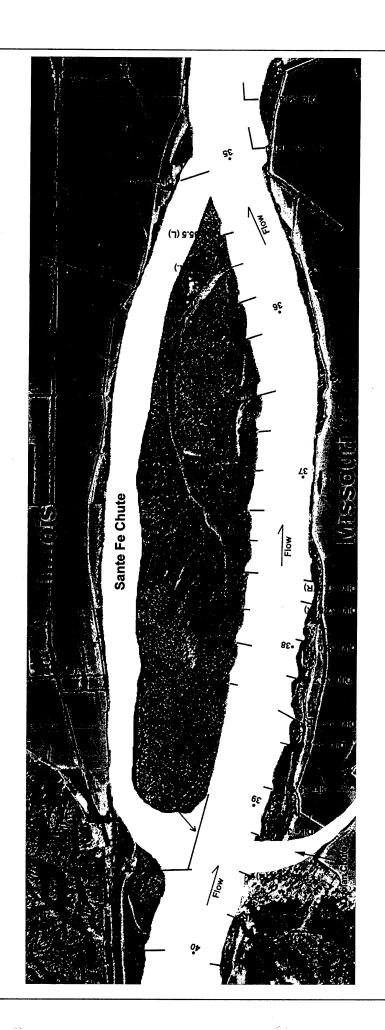
雅	U.S. ARMY ENGINEER DISTRICT, ST. LOUIS CORPS OF ENGINEERS ST. LOUIS, MISSOURI
PREPARED BY: R. HWIGK CHECKED BY: R. Dwinney	Sante Fe/Doolan Chute Micro-Model Study Mississippi River Miles 40 - 35
DATE: 29 July 1988	Photograph of Sante Fe Study Reach
	PLATE NO.

Plate 1 is a map depicting the characteristics, configuration, and nomenclature of the Mississippi River, miles 40 to 35. The upper end of Sante Fe Chute begins at River Mile 39.7L. This side channel parallels the main channel for a distance of approximately 5 miles. Doolan Chute begins at river mile 39.0R and re-enters the main channel at river mile 31.0R.

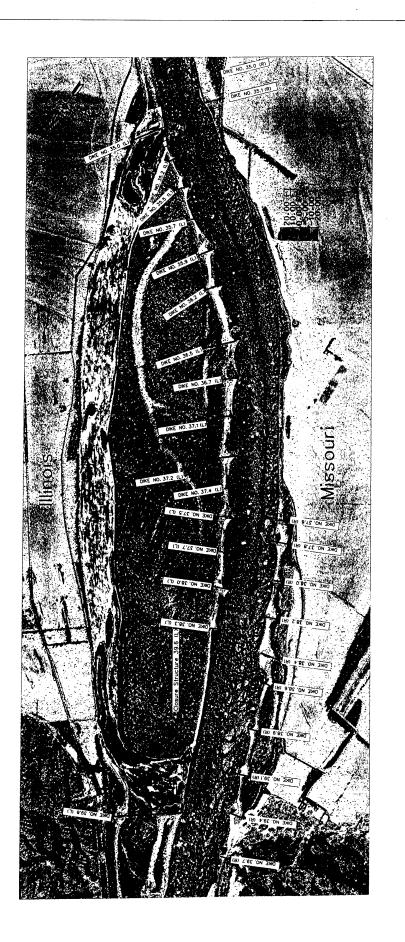
1995 Sonte Fe Chute Prototype

With this premise it is important to note that diversity in the form of alternating bars and deep scour holes were desired in these side channels. This type of habitat does not exist in Sante Fe Chute. Plate 2 is a plan view, 1995 bathymetric survey of Sante Fe Chute. Elevation contour data from this survey indicated that the bed of Sante Fe Chute was relatively high and homogenous throughout most of the chute. A small scour hole occurred in the upper end of the chute just downstream of the spur dike /closure structure at mile 39.6 L. The largest natural scour hole pattern in the chute occurred near mile 39.0 on the left descending bank. Some depth was also noted on the lower end of the chute, however, this was a result of a dredge cut used for nearby levee repair.

- h. In Sante Fe Chute, just upstream of Dike No. 35.0L, a scour hole with depths between -10 and -20 LWRP was artificially molded in the bed. This hole represented the recent dredging site used for the construction of levee repairs after the 1993 flood (see Plate 2). Because of the main channel backwater influence, this hole remained intact during all future tests.

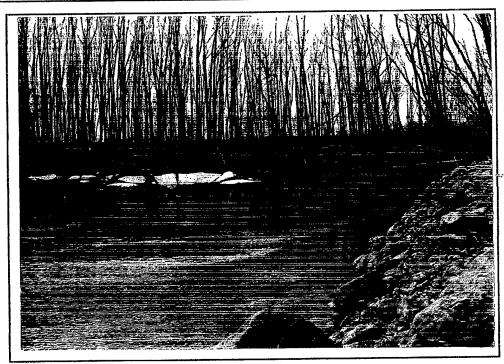
Photograph #1; Doolan Chute

From the tip of dike 39.1, as shown on Plate 5 (Photograph #1), there was no indication of any chute. The bankline was constant across this section, as well as the density and age of the vegetation. Approximately 300 feet inland of the

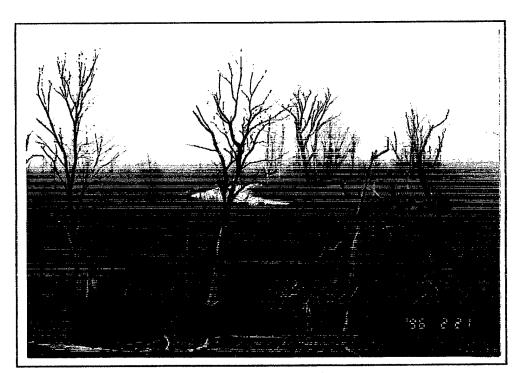
Photograph #4; Doolan Chute

The lower photograph on Plate 6 (Photograph #4) was taken from the levee looking upstream along the northern section of Goat Island. The chute contained a defined channel that was approximately 75-100 feet in width. The transition from the poorly defined channel to the well defined channel occurred approximately ½ to ¾ mile upstream of Goat Island.

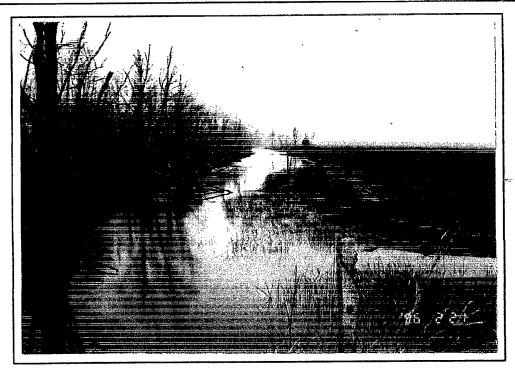
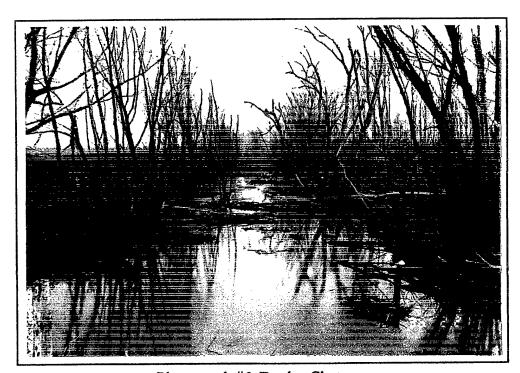
Photograph #5; Doolan Chute

Photograph #6; Doolan Chute

HAH	U.S. ARMY ENGINEER DISTRICT, ST. LOUIS CORPS OF ENGINEERS ST. LOUIS, MISSOURI		S
PREPARED BY: R. Heltick CHECKED BY: R. Downroy		lan Chute Micro Mo ippi River Miles 40	
	Photographs	#5 and #6 of Dool	an Chute
			PLATE NO
			7

The photographs on Plate 7 (Photographs #5 and #6) were taken looking upstream and downstream, respectively, from the road that crossed Doolan Chute, approximately 2 miles downstream of Goat Island. The photographs show the typical channel characteristics that were present between Goat Island and the road crossing. At the road crossing, there was an 8-10 foot diameter steel culvert.

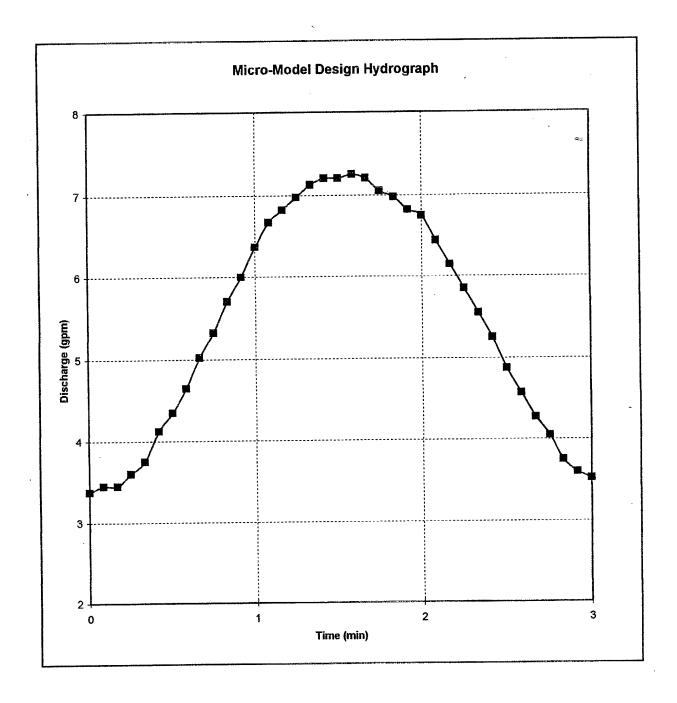
HXH.	U.S. ARMY ENGINEER DISTRICT, ST. LOUIS CORPS OF ENGINEERS ST. LOUIS, MISSOURI	
PREPARED BY, R. Helrick CHECKED BY, R. Devinroy	Sante Fe/Doolan Chute Mic Mississippi River Mile	
	Effective Discharge H	ydrograph
		PLATE NO.
		11

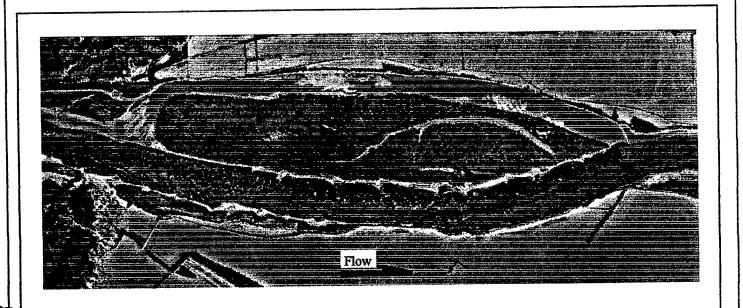
HAH	U.S. ARMY ENGINEER DISTRICT, S CORPS OF ENGINEERS ST. LOUIS, MISSOURI	ST. LOUIS
PREPARED BY: R. Helrick CHECKED BY: R. Davinnoy	Sante Fe/Doolan Chute Micro Mod Mississippi River Miles 40 -	lel Study 35
	Prototype Ice Photo	
		PLATE NO.
		12

Several prototype surveys were used to determine the general bed characteristics that existed in the prototype (Plates 2, 8, and 9). A 1994 low water ice photograph of the study reach of the Mississippi River was also used to compare surface flowlines (Plate 12).

Plates 14 and 15 are flow visualizations of the main channel and Sante Fe Chute, respectively. Nearly identical patterns were seen in the flow visualization of the base test condition in the micro model as compared to the ice photo on plate 12.

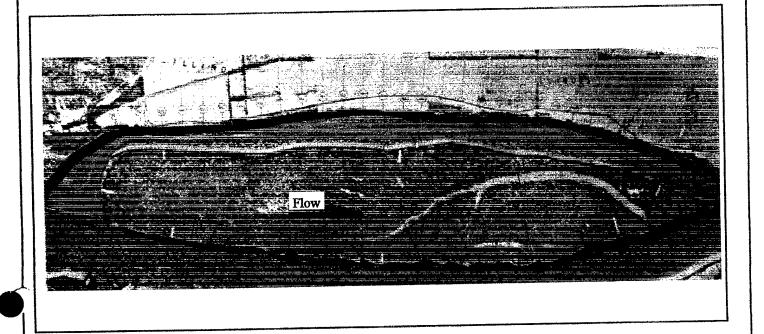
HAH	CO	IGINEER DISTRICT, S RPS OF ENGINEERS . LOUIS, MISSOURI	T. LOUIS
PREPARED BY: R. Hetrick CHECKED BY: R. Dawnoy	Sante Fe/Do Missis	oolan Chute Micro-Mod ssippi River Miles 40 - 3	el Study 35
	Flow Visualization	n of Sante Fe Chute Ba	se Conditions
}			PLATE NO.
			15

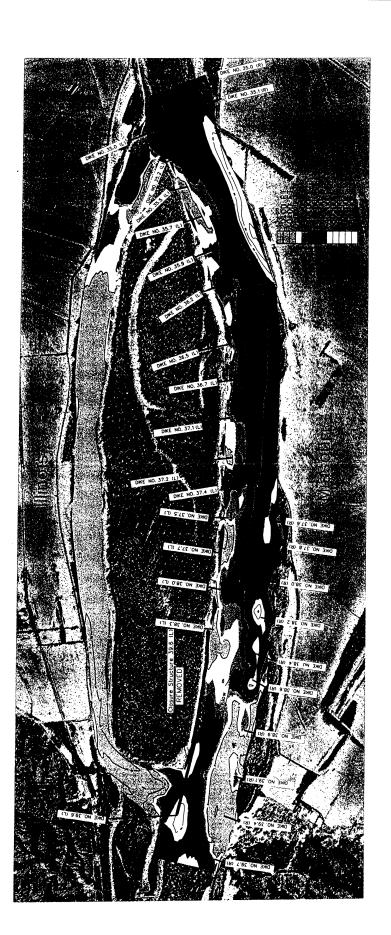
Sonte Fe/Doolon Chute Micro Model Study
Mississippi River Miles 40 - 35
ALTERNATIVE A
CLOSURE STRUCINE 39.6(L) REMOVED
